Tech Note

TX-E201 & TX-E231 Battery Clip Issue

Applies to Product with Date Code Prior to 18105

Release Date: 06/19/2019

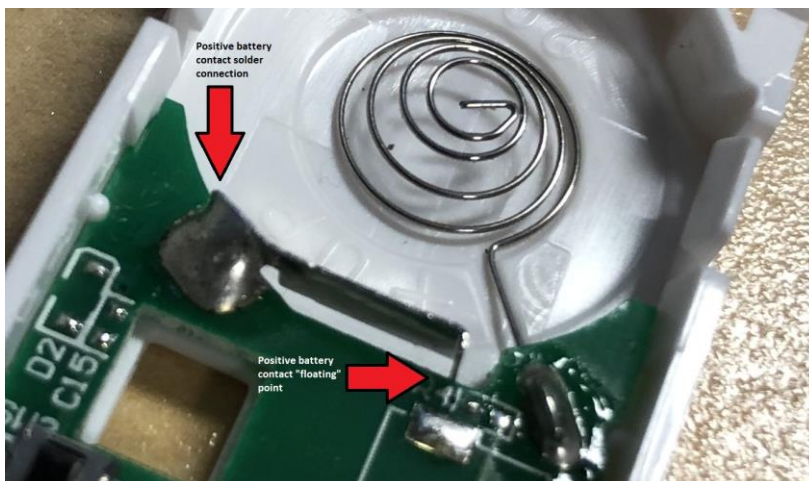
1. Some TX-E201 and TX-E231 units with date codes prior to 18105 may appear to have a “dead” battery, even if battery voltage measurements suggest adequate capacity to operate the sensor.
2. The root causes of this condition have been isolated to two factors: A misalignment of the positive battery contact, and use of a metal material with insufficient stiffness for the positive battery contact.

3. The misalignment of the positive battery contact usually occurs at the factory during production, but can also occur due to product damage in the field. In the factory case, the positive battery contact can be soldered with incorrect alignment, due to inconsistent or incorrect use of the corresponding soldering fixture. The field misalignment usually occurs when the technician accidentally bends the flimsy positive battery contact away from the battery during battery insertion or extraction.

4. When the battery contact assembly is misaligned, the battery's positive electrode will not make proper contact with the sensor circuit, such that it can sustain normal sensor operation. This condition will give the impression that the battery is "dead".

1. Units with a date code on or after 18105 have been built with a stiffer metal for the positive battery contact, using a more robust production fixture and rigorous soldering strategy.
2. Do not to use any TX-E201 or TX-E231 Door/Window Sensor units with misaligned battery contacts.
3. Utilize the normal RMA process to return the affected units for replacement.
